**Conservation Engineering Survey and Assessment Report**

**Spirit of Newfoundland (Masonic Temple),  
Cathedral Street,  
St. Johns,  
Newfoundland.**

**Date:** 3<sup>rd</sup> July 2018

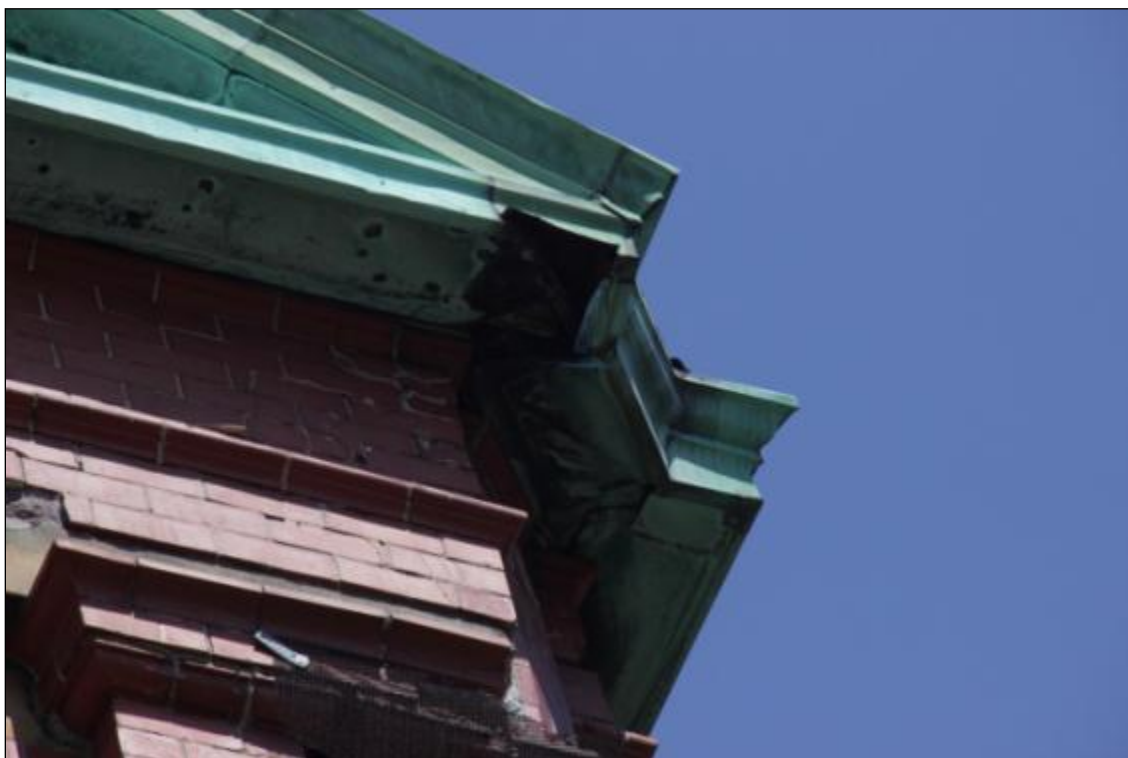
**Photo 28 - Damaged corner of copper fascia and soffit**

- Opening up works to be carried out including removal of sections of the copper fascia and soffits to assess condition of timber underneath. Inspection of timber formwork behind the 3 no. decorative panels.

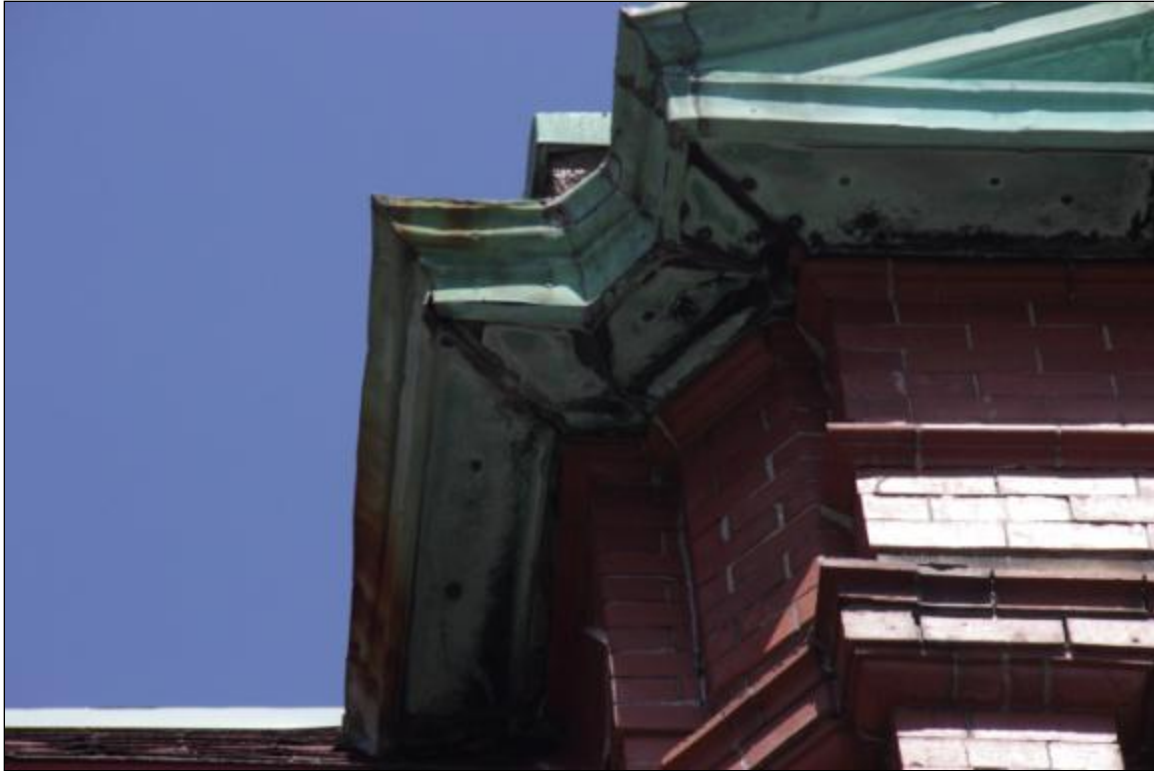
**Photo 29 - Bi-metallic staining and evidence of corrosion of the copper on corner of central tower**

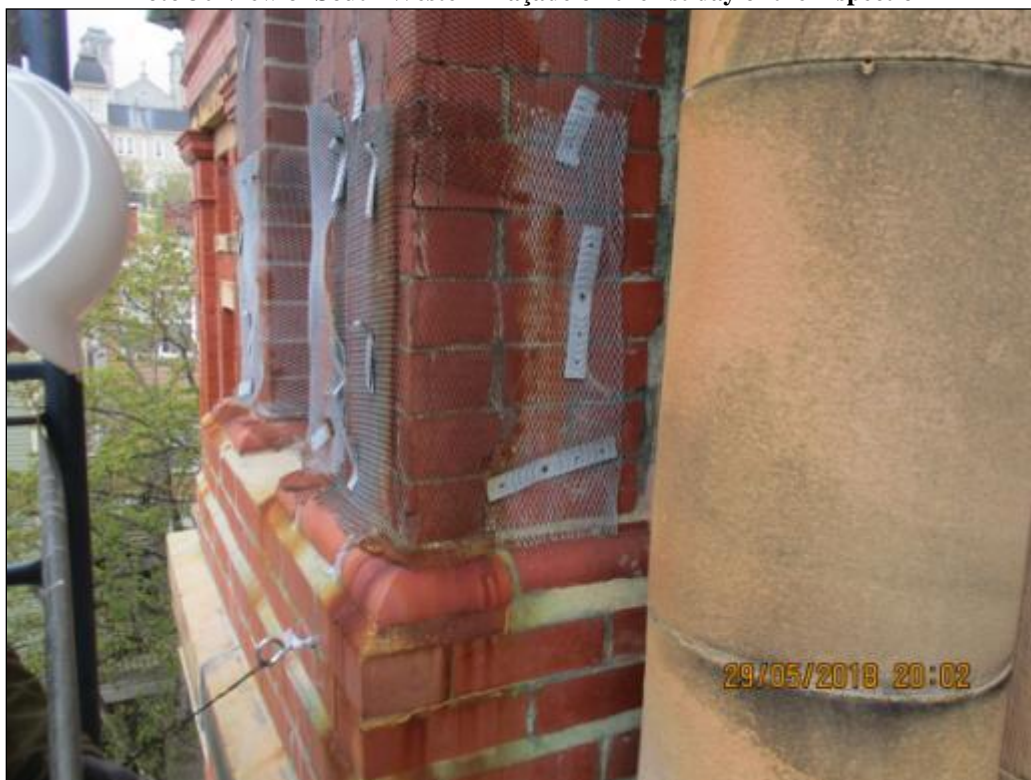
**Photo 31 - View of netting to brickwork**

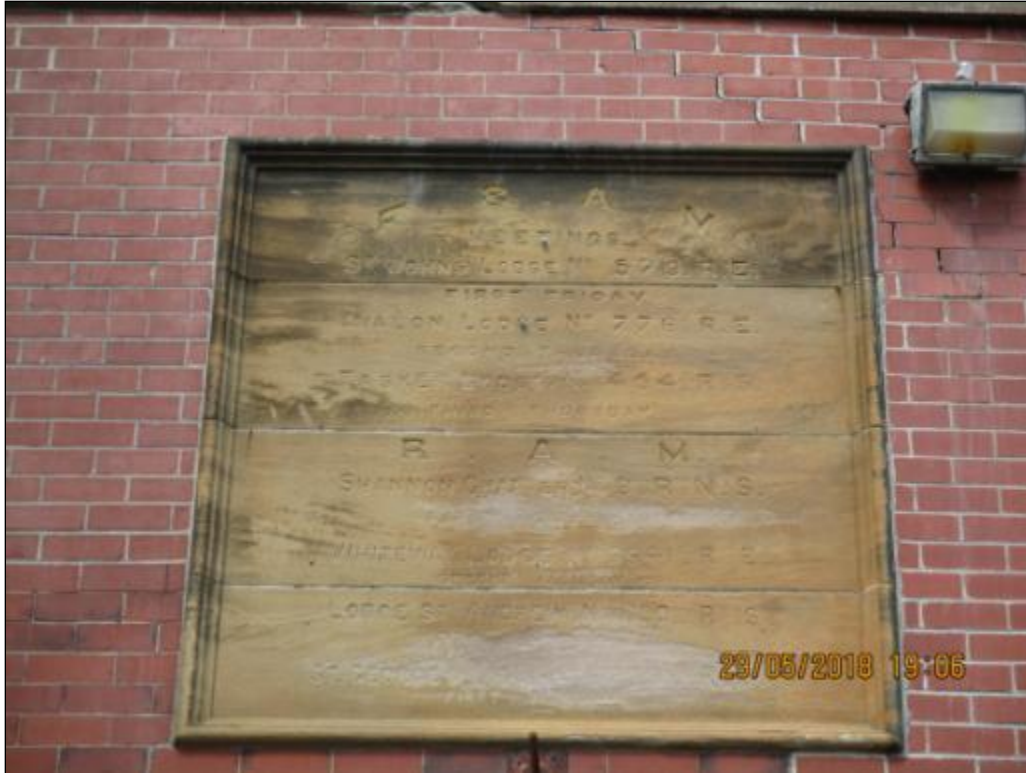
**Photo 32 - View of badly deteriorated sandstone panel with inappropriate brick replacement surround.**

- Removal of inappropriate brick panel and replacement with bricks to match the original, laid in a Natural Hydraulic Lime based mortar, gauged to match existing brick coursing.

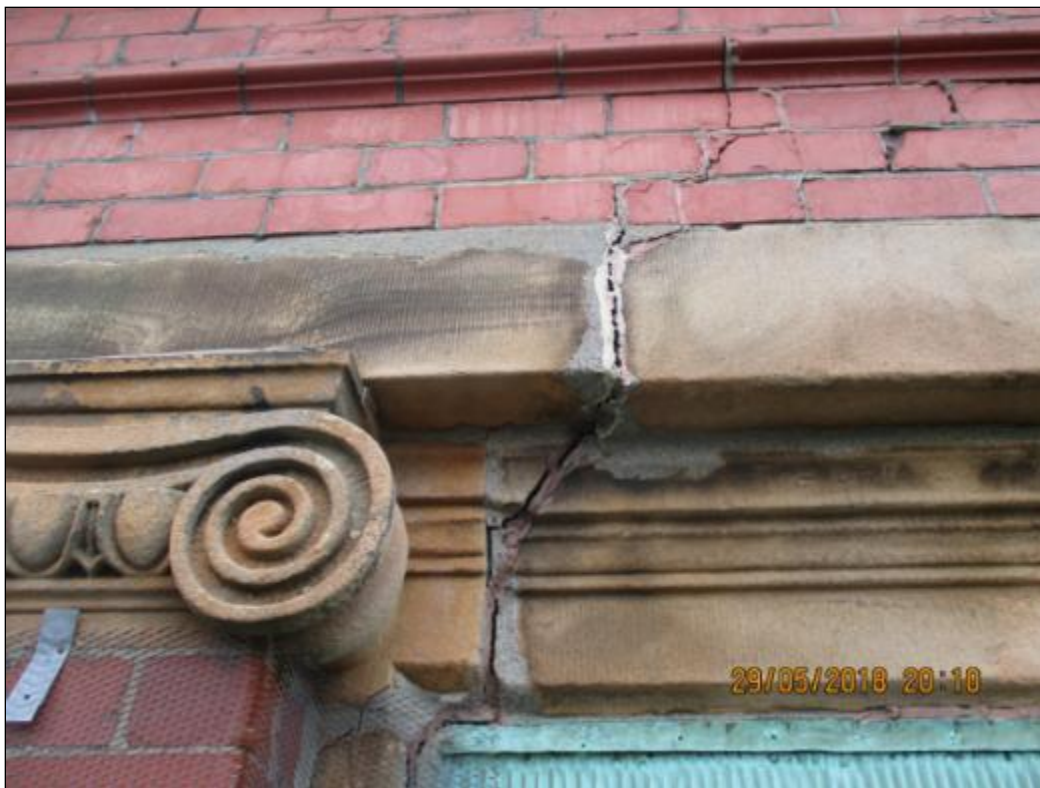
**Photo 33 - View of sand stone unit with failure through joints and inappropriate interventions.**

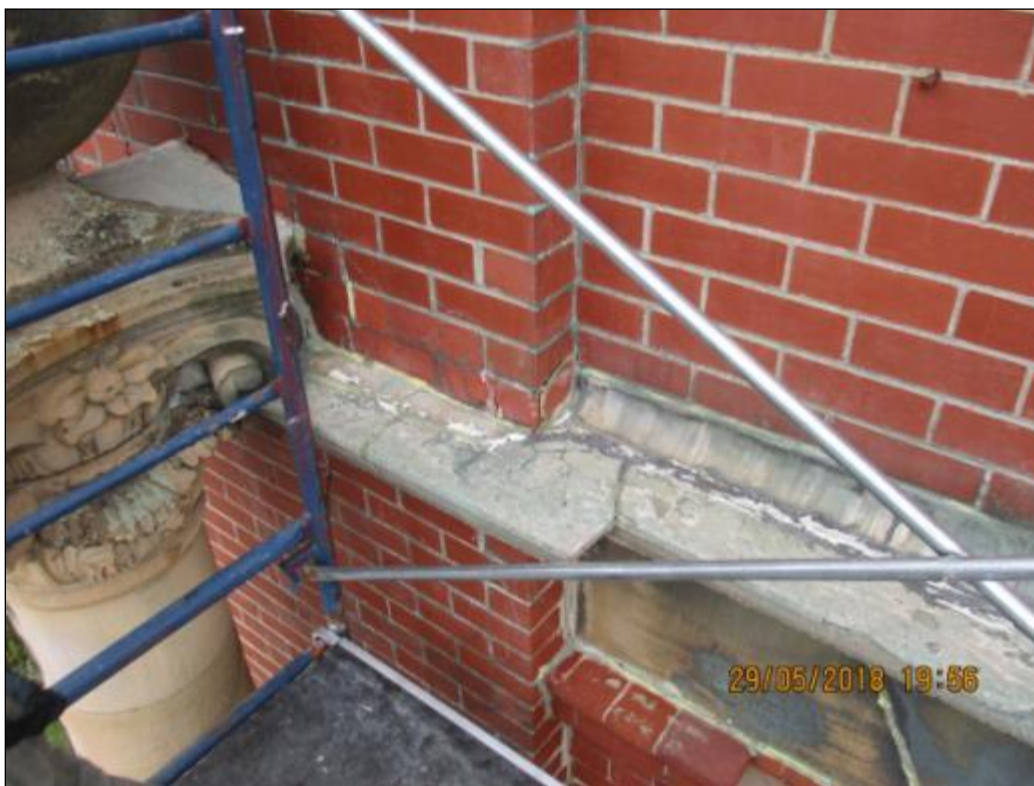
Photo 34 - View of corbel string course with various previous interventions on view.

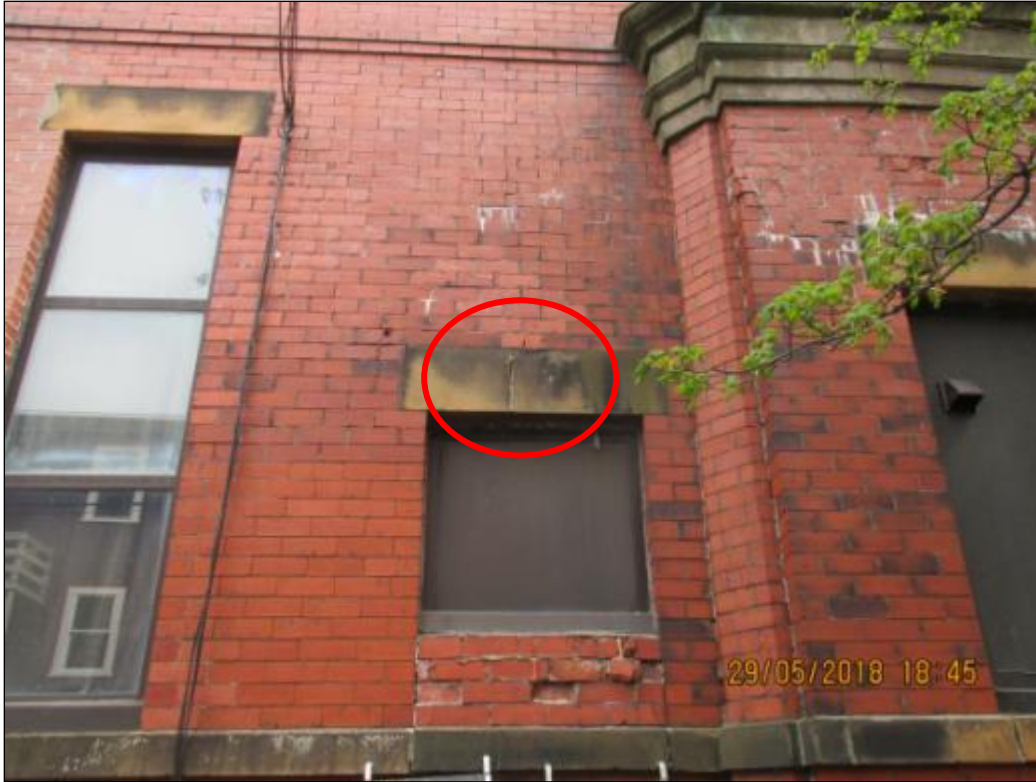
**Photo 36 - View of various openings with vertical crack on view to lintel to central foreground of photograph**

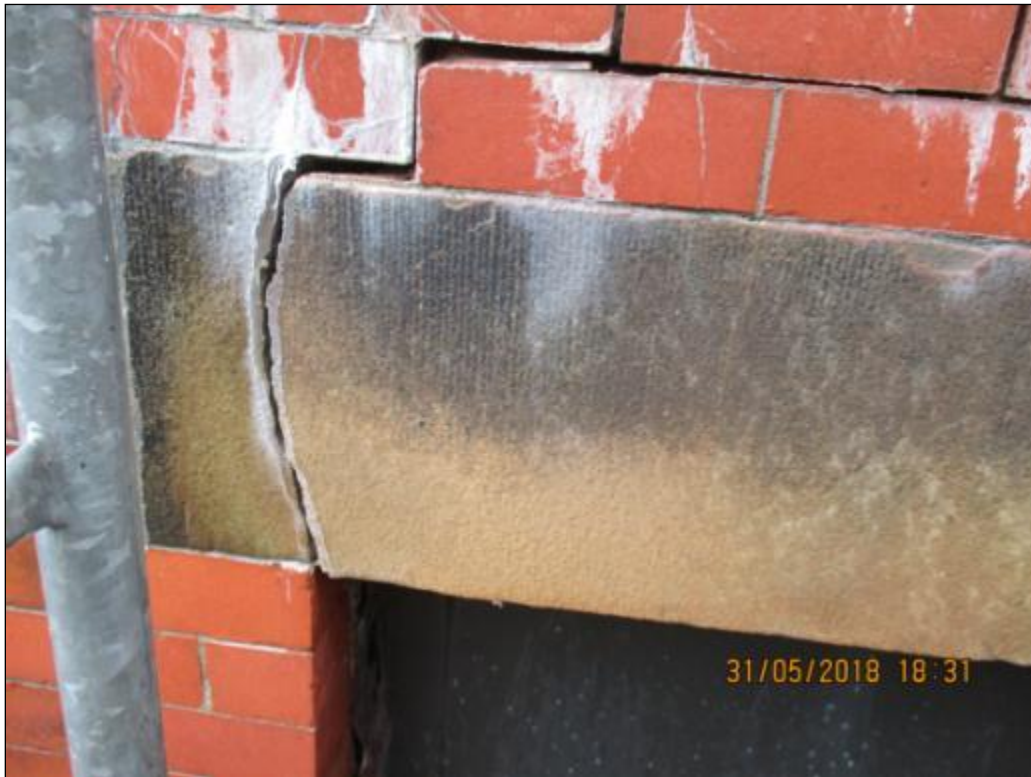
**Photo 37 - Crack to lintel at NW/SW corner.**

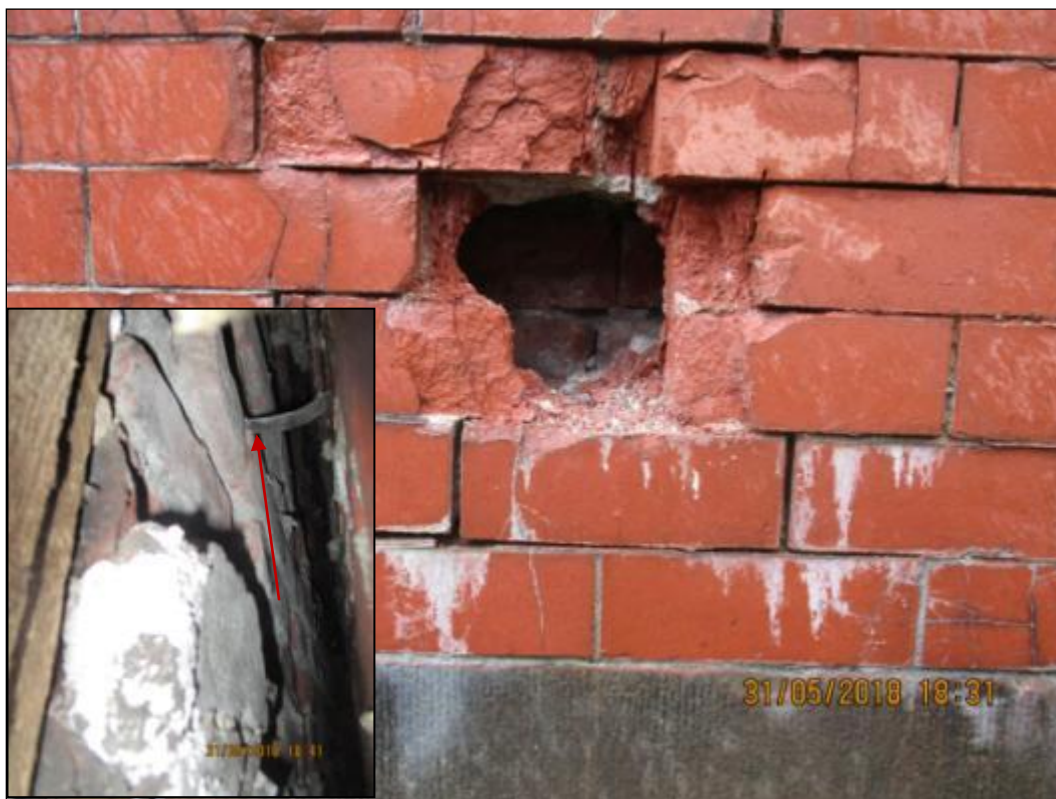
**Photo 38 - Exploratory opening in outer brick leaf. Inset; View of Lead tie.**

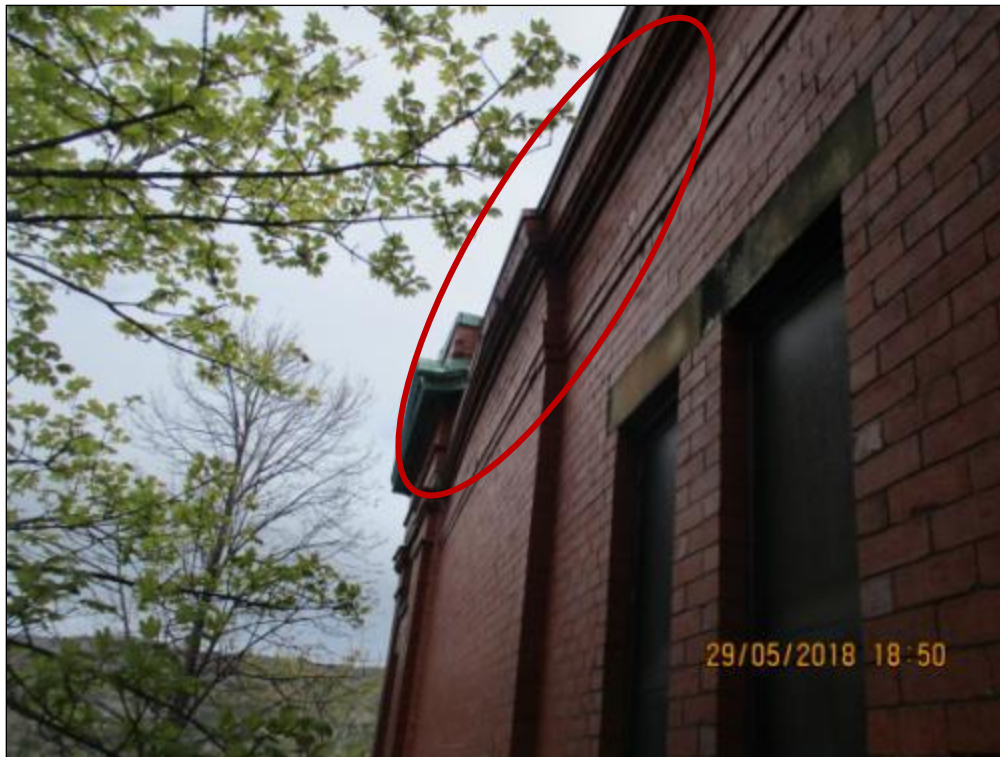
**Photo 40 - View of eaves of North Eastern facade with masonry leaning outwards on the corbel courses**

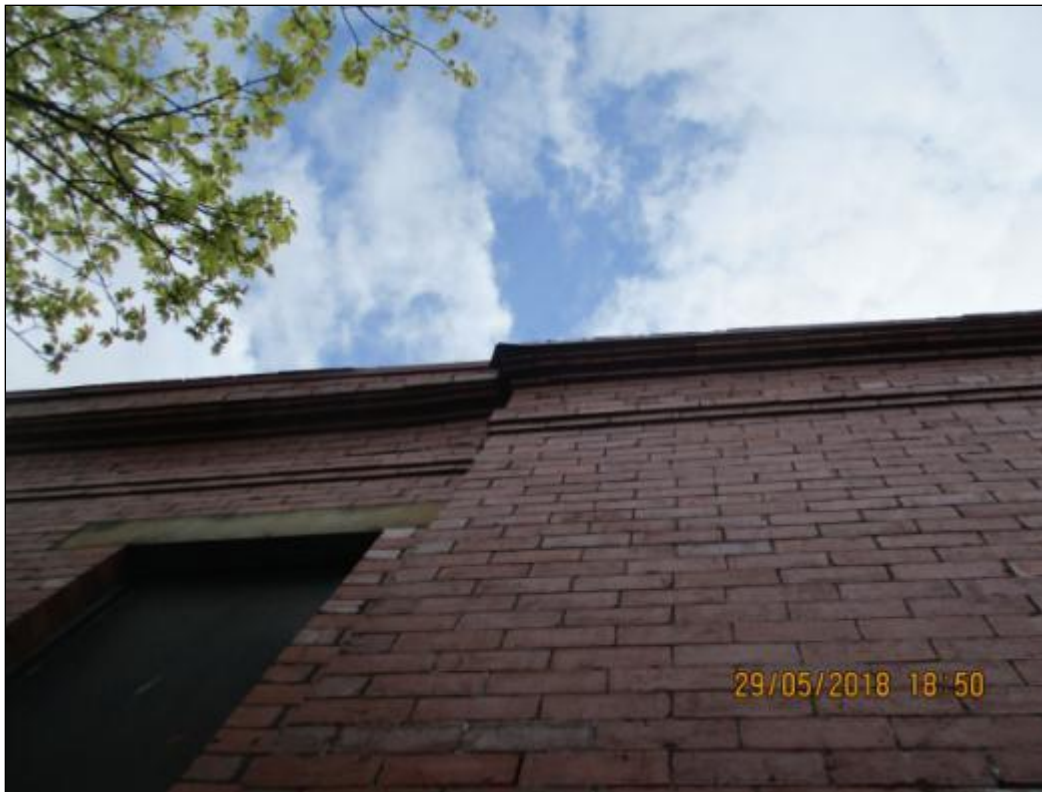
**Photo 41 - View from below leaning masonry**

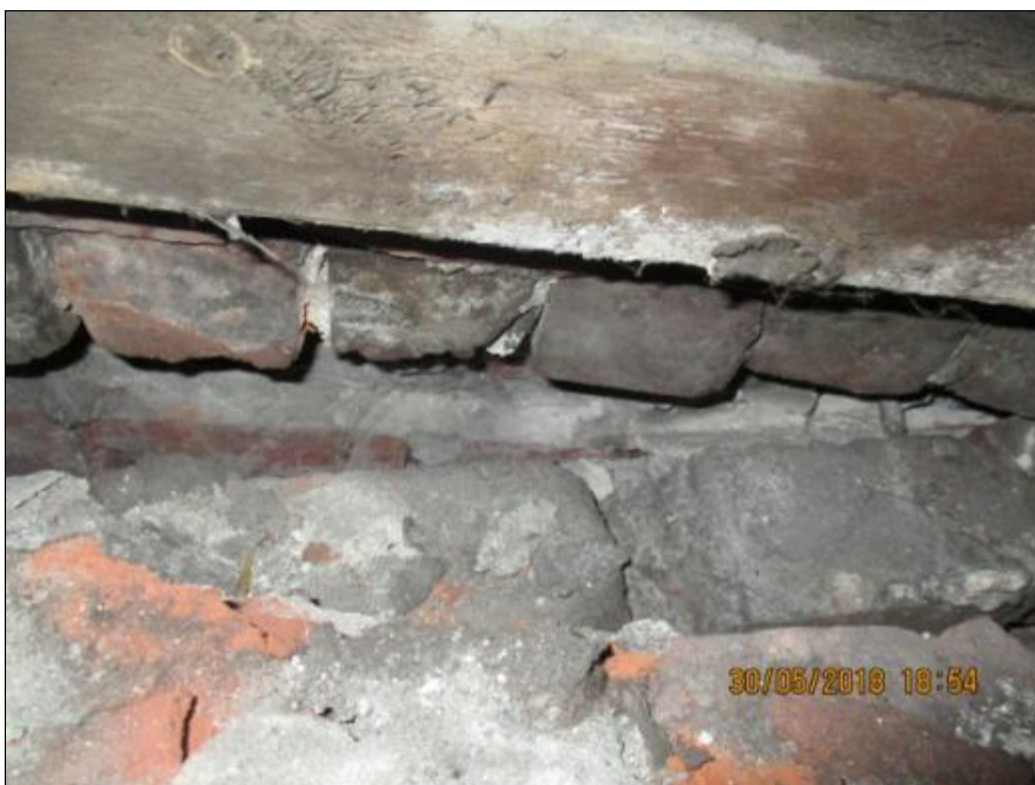
**Photo 42 - Internal view of failed brickwork at eaves**

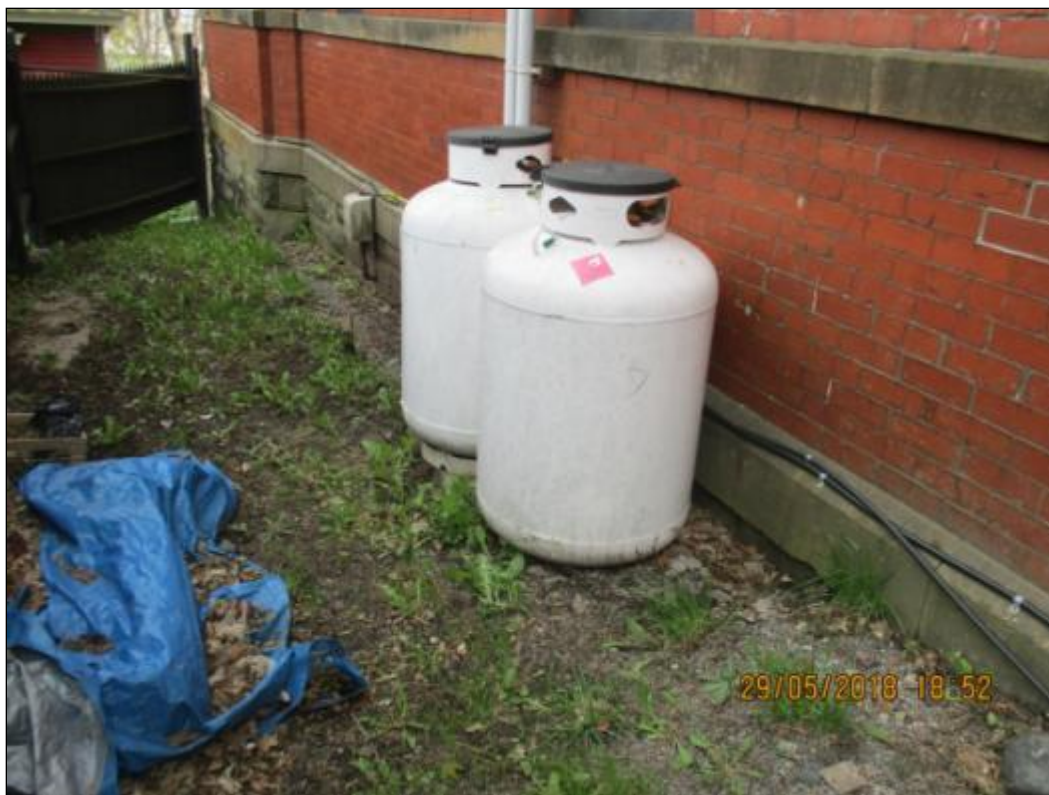
**Photo 43 - Flammable gas tanks beneath the failed masonry.**

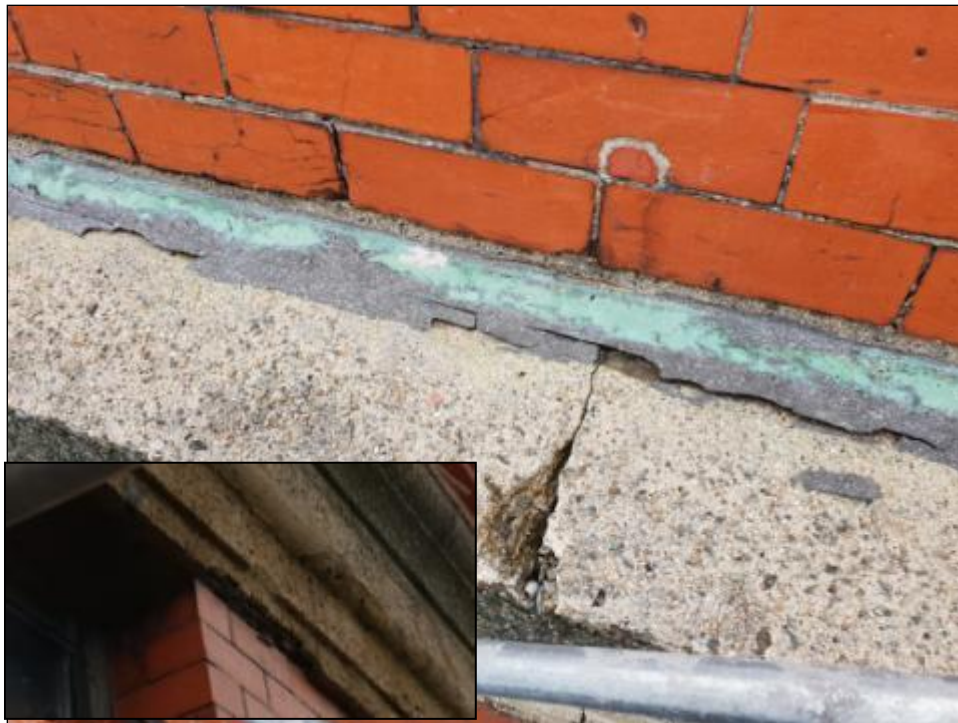
**Photo 46 - View of top of cornice string course at storey level. Fabric and flashing in poor repair.  
Inset spalling of concrete surface with steel reinforcement exposed.**

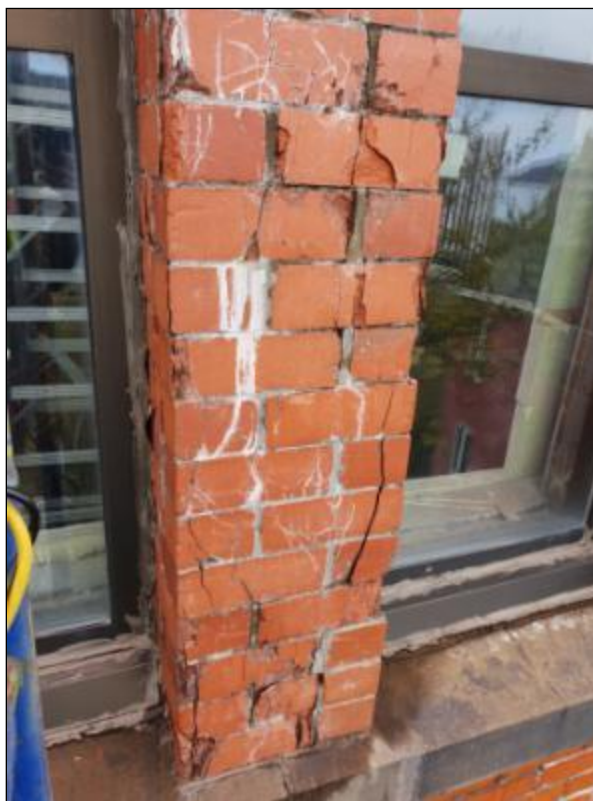
**Photo 47 - View of crumbling brickwork to brick panel.**

- Removal of weak and failed mortar to the joints of the brickwork.
- Application of brick joint reinforcement measures.
- Application of brick tie through to backing masonry to replace failed/missing or nonexistent wall ties (The brick is laid in a stretcher bond throughout, lead ties were found on the North West Façade exploratory opening up works).

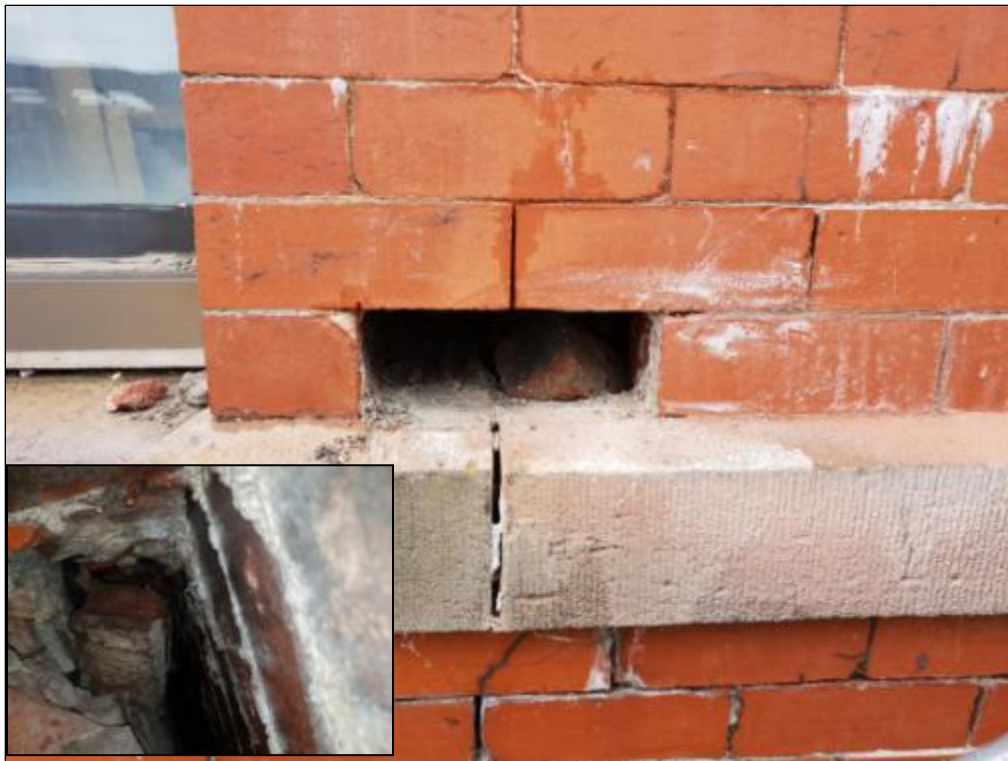
**Photo 48 - View of exploratory opening up. Inset; view inside cavity with fallen masonry evident to the middle foreground.**

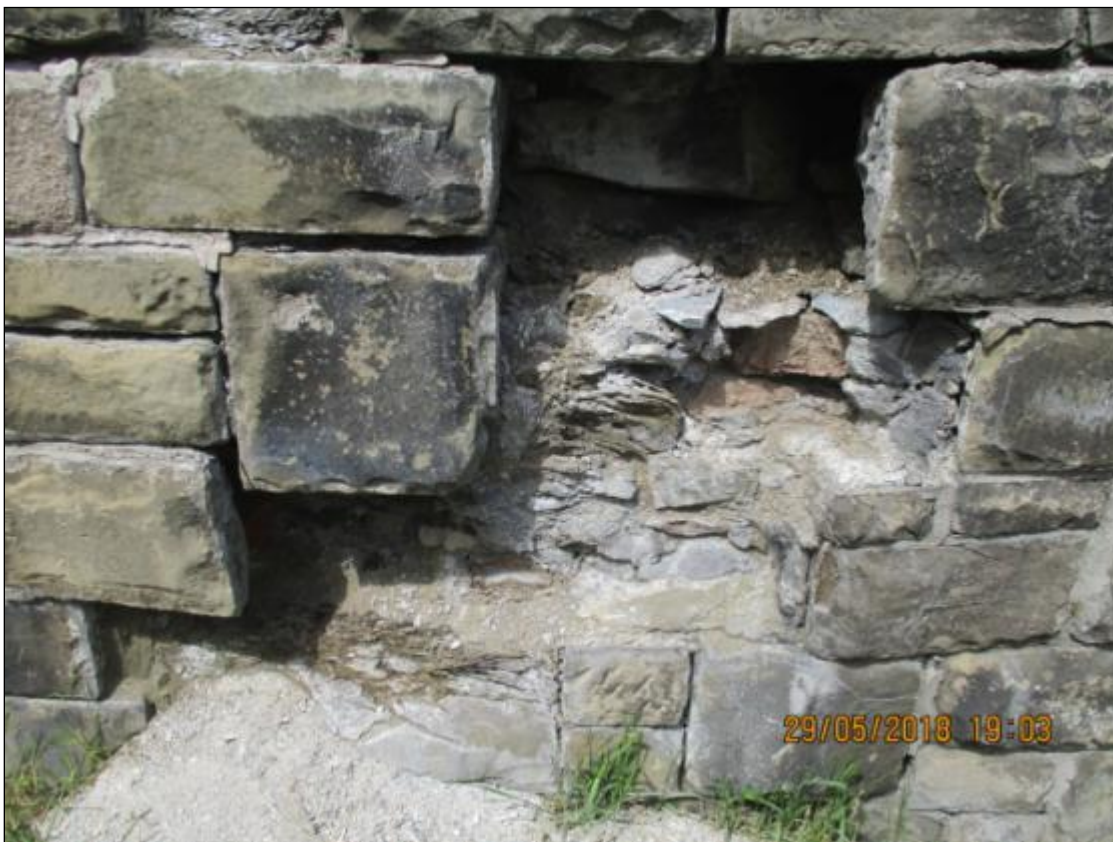
**Photo 49 - View of deterioration of masonry of retaining wall to front of entrance**

- Removal of cementitious mortar pointing interventions, mastic and silicone interventions.
- Repair of failed masonry units using a Natural Hydraulic Lime based stone repair and restoration mortar and or stone indent repairs, dependant on the severity of the failure and size/location where stipulated.
- Pinning of failed stone masonry where required.
- Where necessary, replacement of failed stone masonry units with new units, finished to match existing.
- Removal of weak and failed mortar to the joints of the masonry.
- Application of joint reinforcement measures if deemed necessary.
- Application of tie through to backing masonry if found necessary.
- Application of a Natural Hydraulic Lime based mortar pointing to the masonry where required on completion of the afore mentioned works.

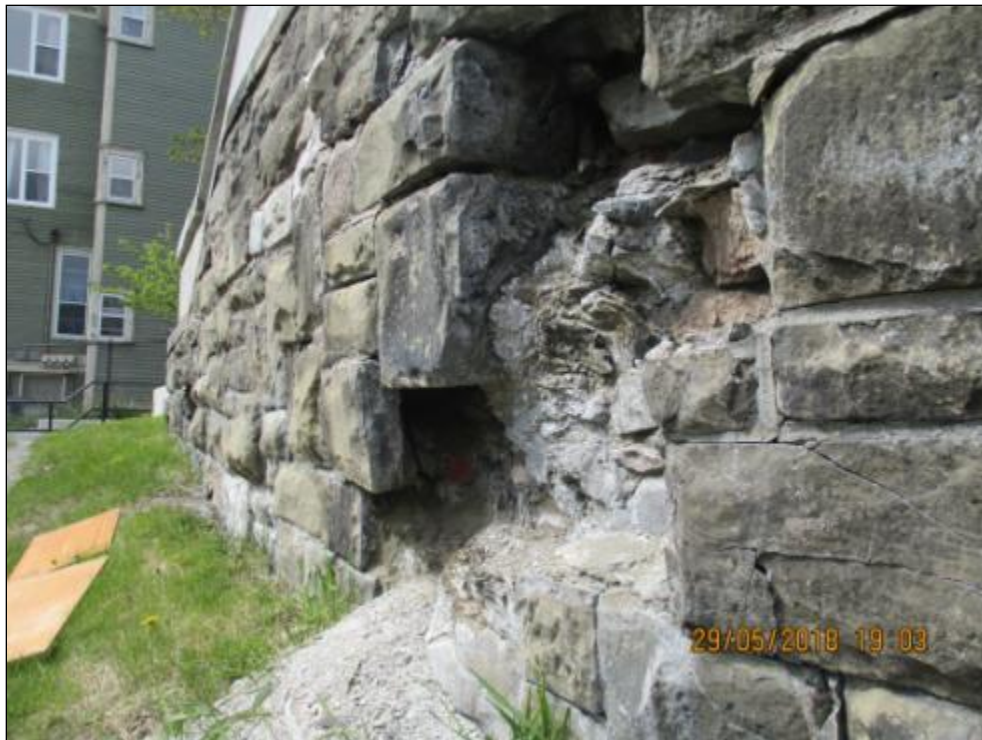
**Photo 50 - View of deterioration of masonry of retaining wall to front of entrance**

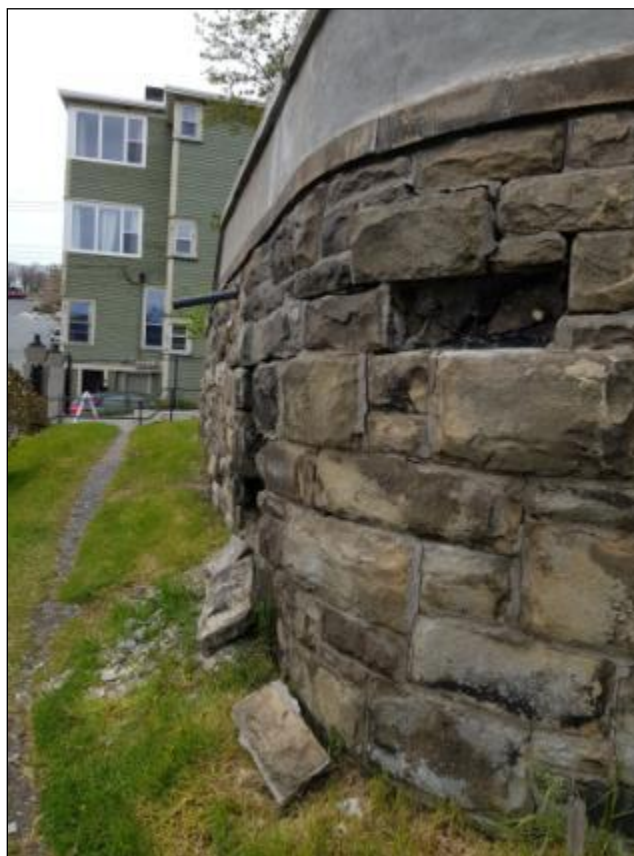
**Photo 51 - View of deterioration of masonry of retaining wall to front of entrance.**

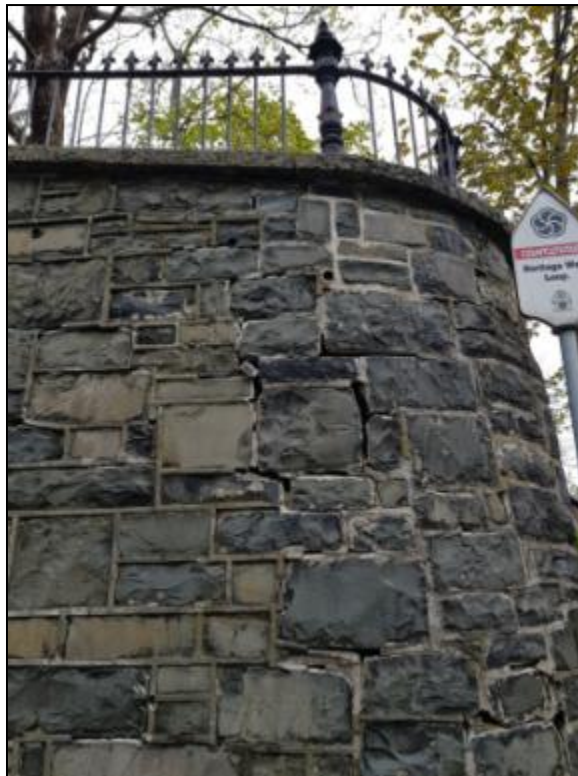
**Photo 53 - View of deterioration of cementitious pointing to corner of retaining wall.**

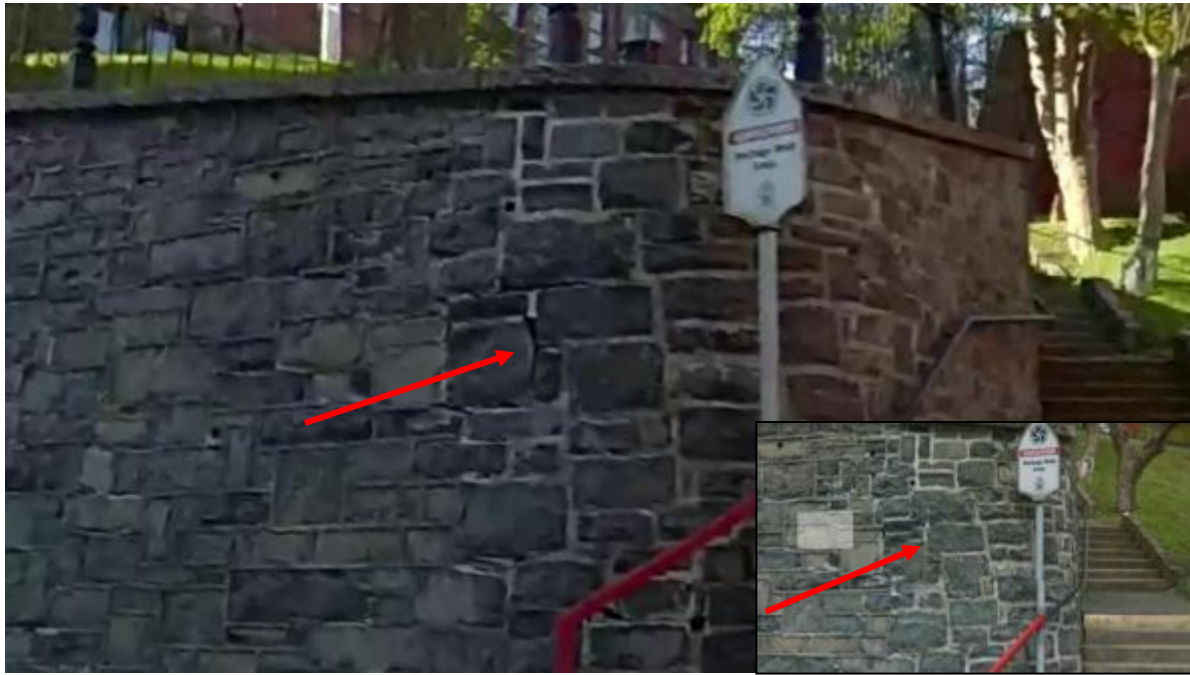
**Photo 54 - Google Street view captures from May 2018 (Main) and May 2013 (Inset) illustrating the deterioration of the cementitious pointing applications over time.**
